Re: Notice of Violation  
Compliance Evaluation Inspection  
EPA I.D. No.: INR000007161

COMPLIANCE EVALUATION INSPECTION REPORT

INSTALLATION NAME: Rochester Metal Products Corporation

DATE OF INSPECTION: March 5, 2014

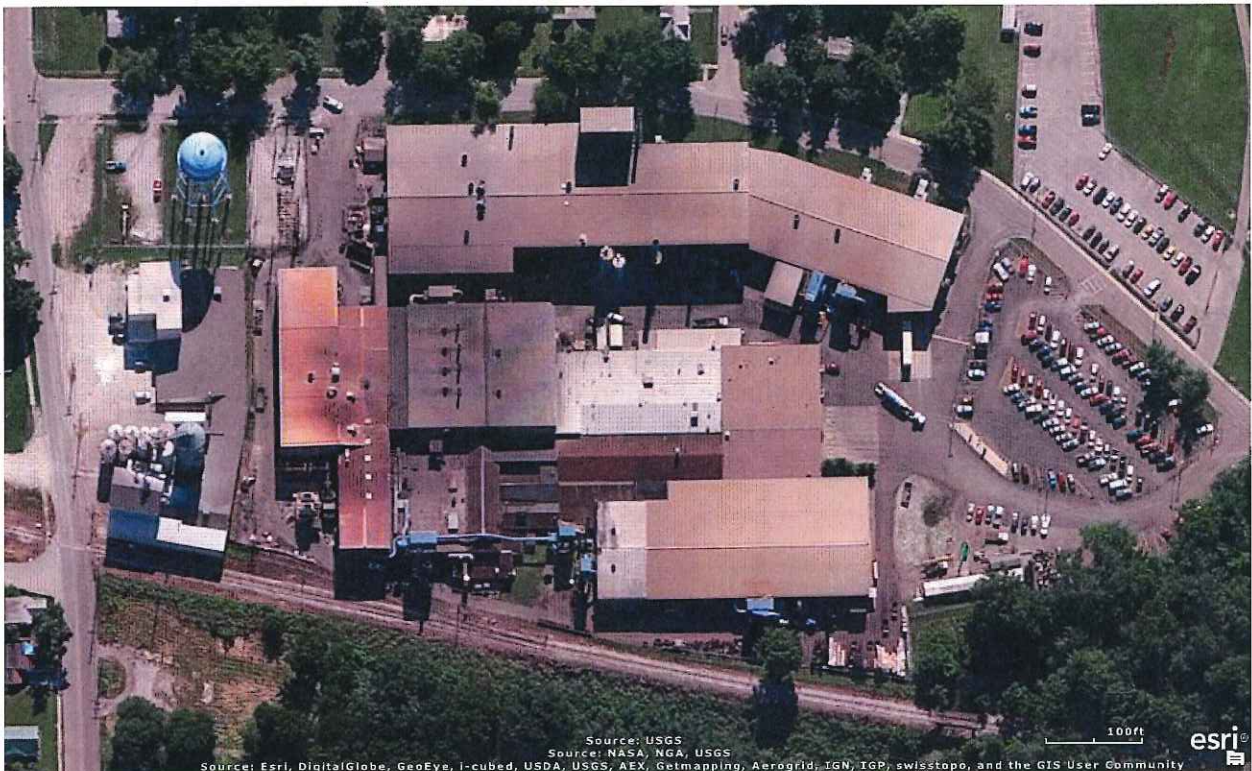
Figure 1: Aerial view of Rochester Metal Products Corporation.

Rochester Metal Products Corporation (Rochester) operates an iron foundry for production of both ductile and gray iron casts (Figure 1). It has approximately 350 employees.

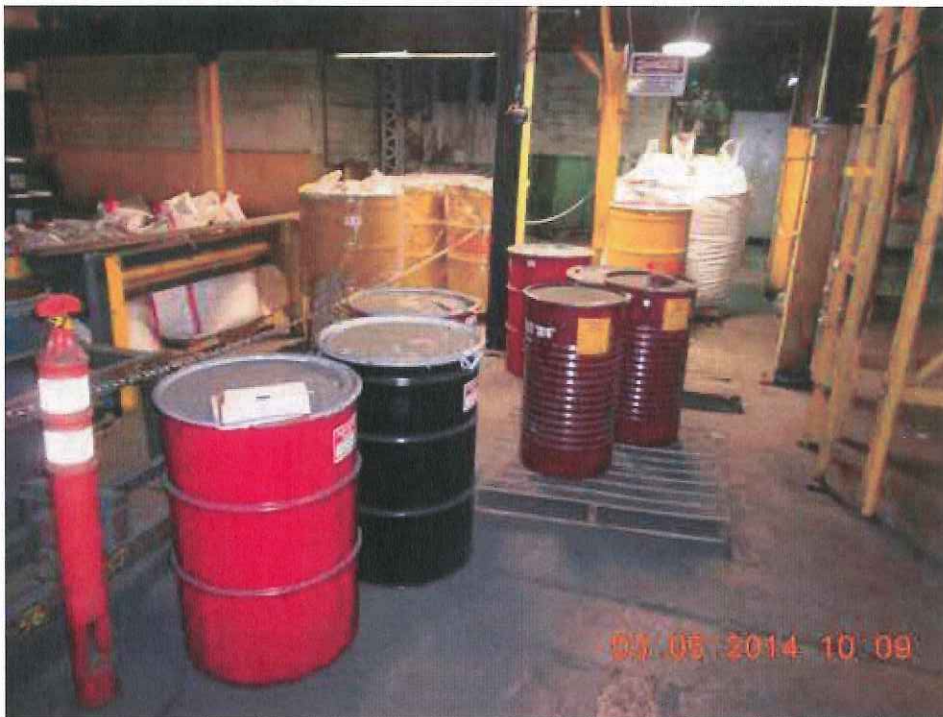
**Photo Number** 1  
**Photo Filename** DSCN0626.JPG  
**Date/Time** 3/5/2014  
10:09:22 AM  
**Photographer** Todd Brown

The following containerized wastes were present in the hazardous waste storage area (photograph 1):

Containers present in the hazardous waste storage area.

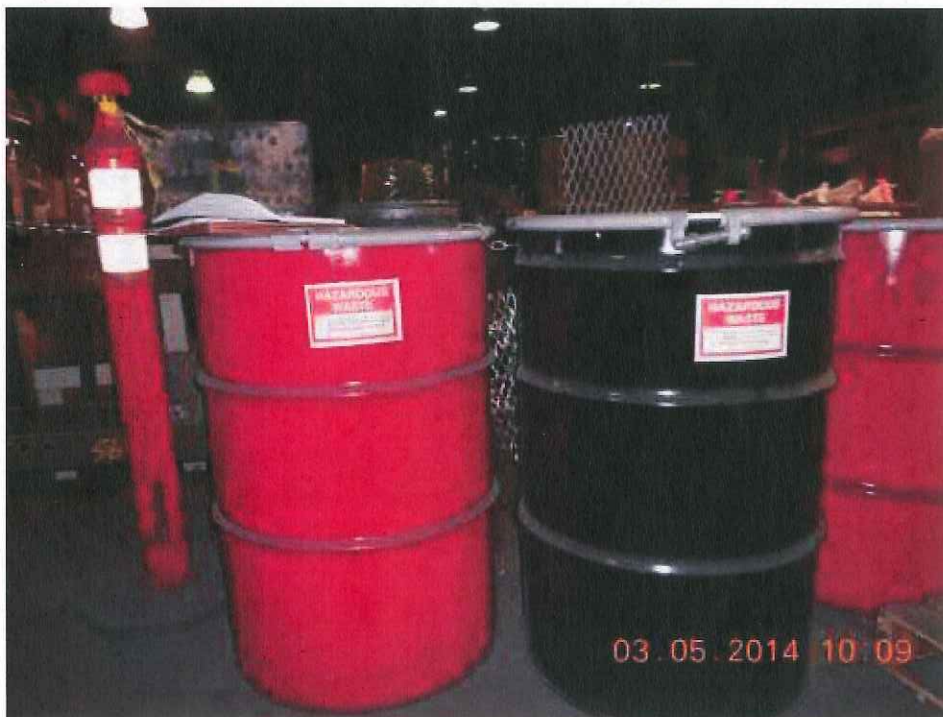
**Photo Number** 2  
**Photo Filename** DSCN0627.JPG  
**Date/Time** 3/5/2014  
10:09:34 AM  
**Photographer** Todd Brown

Containers of paint waste (left) and aerosol can waste (right) in the hazardous waste storage area.

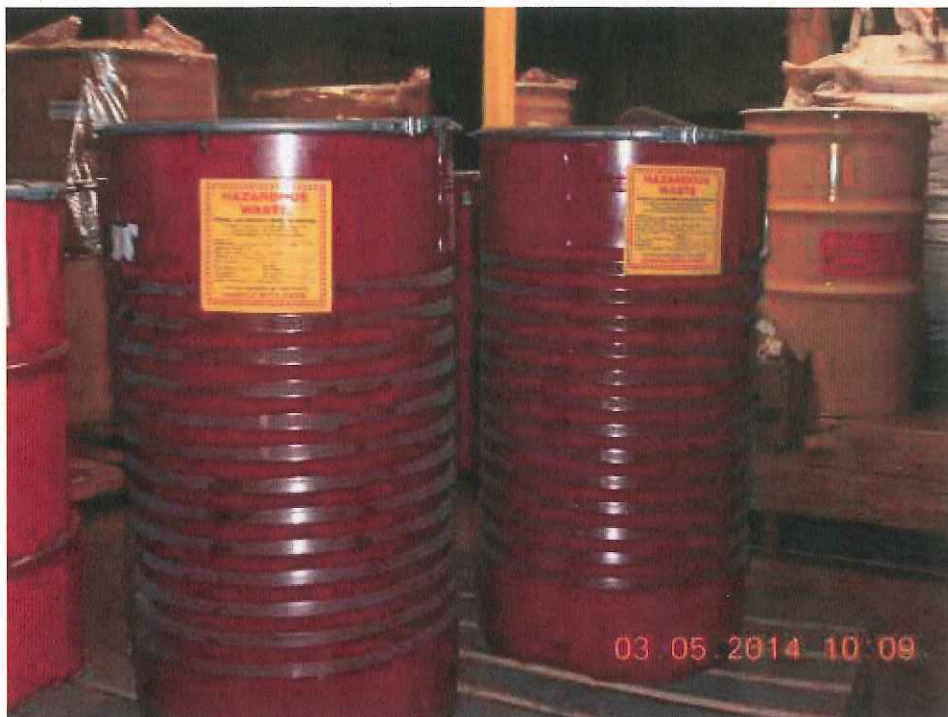
**Photo Number** 3  
**Photo Filename** DSCN0628.JPG  
**Date/Time** 3/5/2014  
10:09:44 AM  
**Photographer** Todd Brown

Containers of diesel fuel waste in the  
hazardous waste storage area.

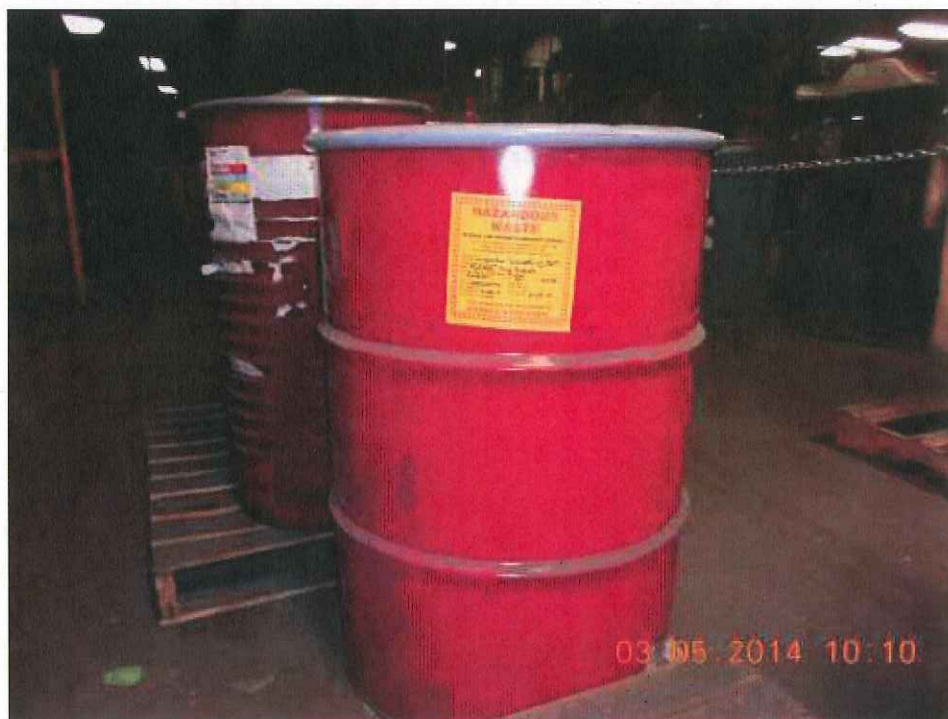
**Photo Number** 4  
**Photo Filename** DSCN0629.JPG  
**Date/Time** 3/5/2014  
10:10:10 AM  
**Photographer** Todd Brown

Container of dust collector waste in the  
hazardous waste storage area.

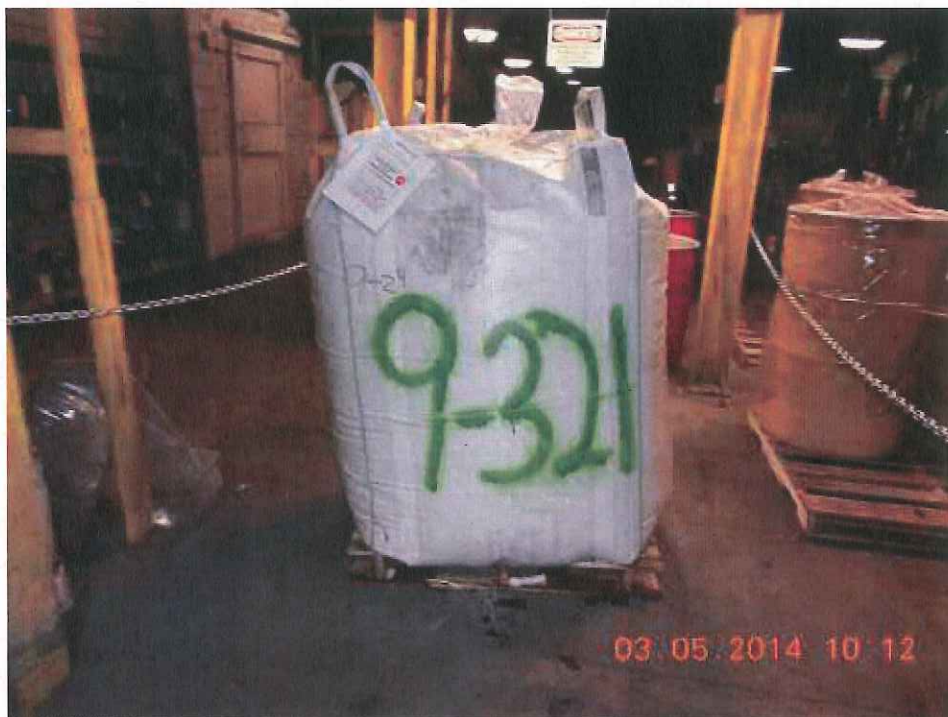
**Photo Number** 5  
**Photo Filename** DSCN0630.JPG  
**Date/Time** 3/5/2014  
10:12:14 AM  
**Photographer** Todd Brown

Container of melt dust fines waste from the #9 dust collector, located in the hazardous waste storage area. At the time of the inspection, the contents were undergoing hazardous waste analysis (photograph 6).

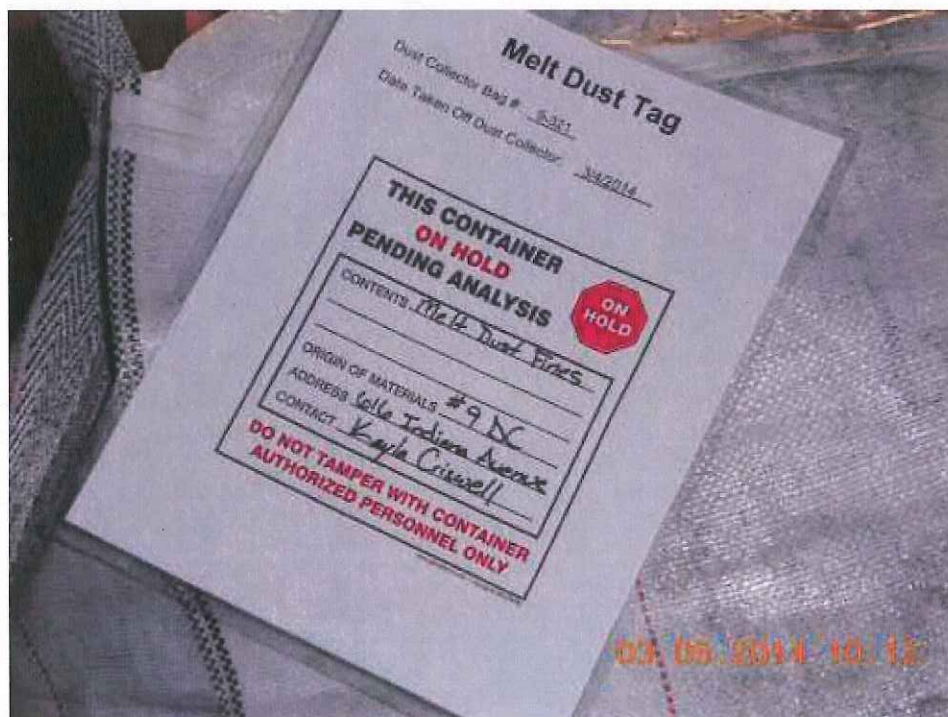
**Photo Number** 6  
**Photo Filename** DSCN0631.JPG  
**Date/Time** 3/5/2014  
10:12:26 AM  
**Photographer** Todd Brown

Label on the bag of melt dust fines featured in photograph 5.

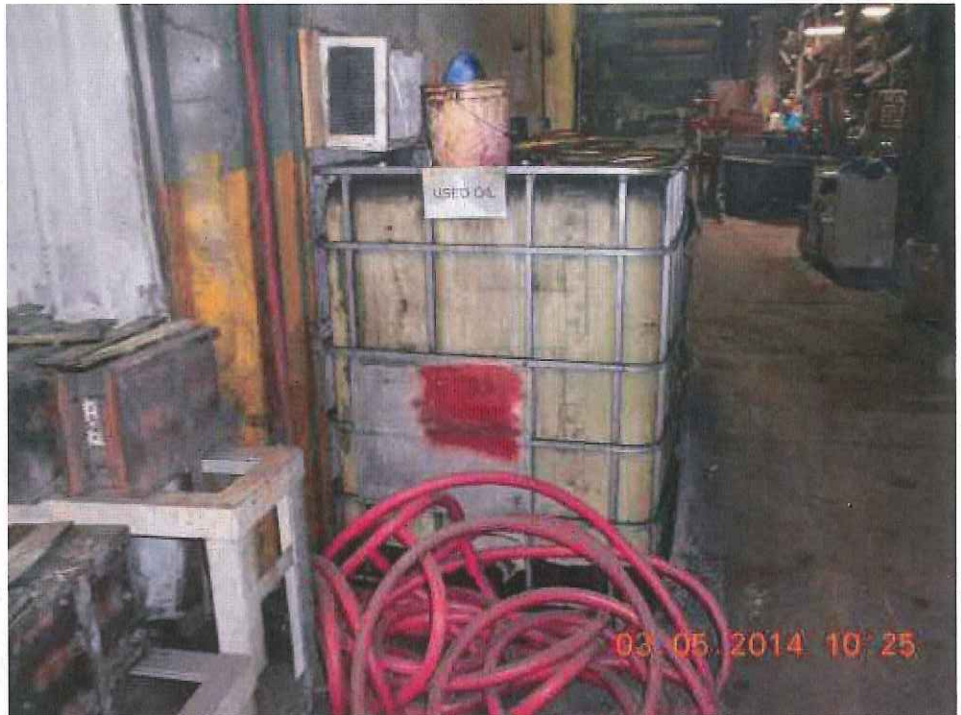
**Photo Number** 7

A used oil tote container was located at the Truck Shop (photograph 7), and a tank for bulk

Container of used oil located outside of the  
Truck Shop.

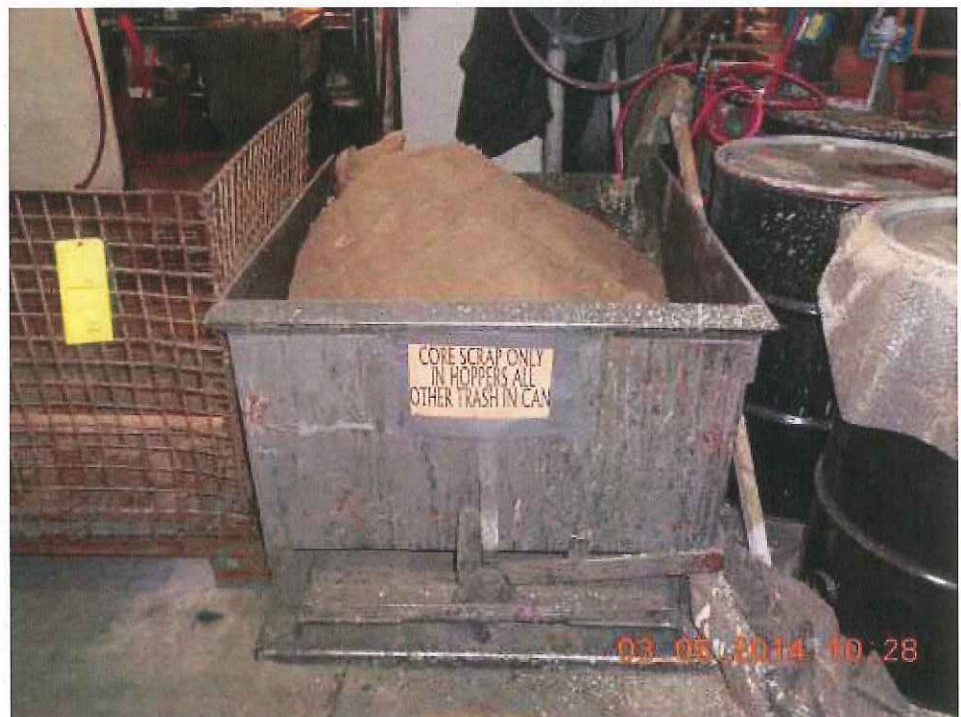
**Photo Number** 8

I noted a hopper for collection of core waste located at the cold box coring area (photograph 8).

Hopper containing waste core material  
generated from cold box coring.

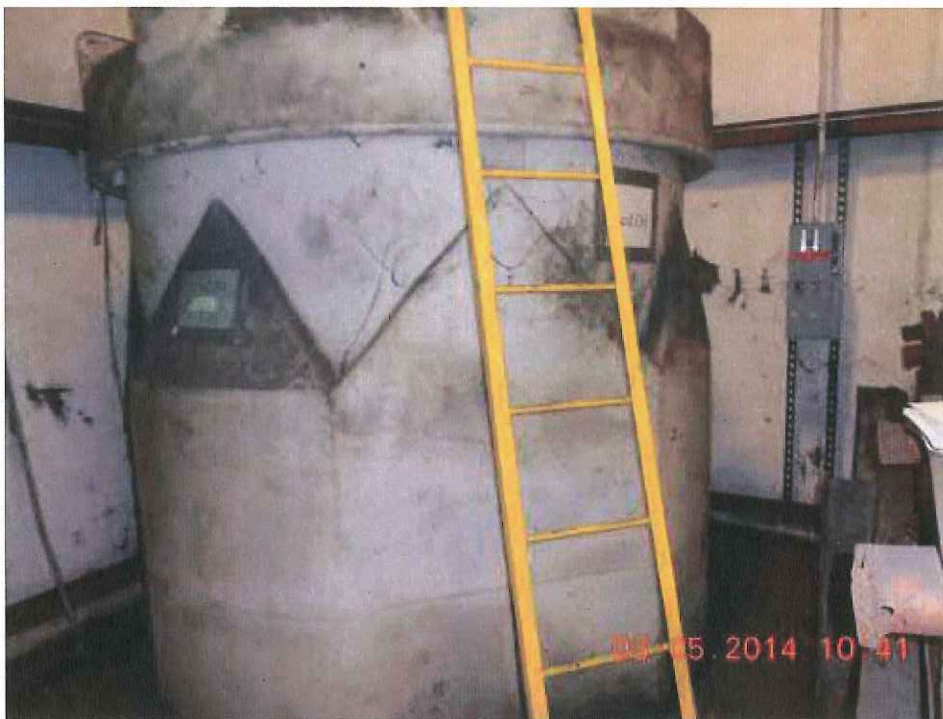
**Photo Number** 9

collection of used oil was located at the Finishing Department (photographs 9 and 10). Both were labeled, "Used Oil."

Used oil bulk collection tank located in the  
finishing department.

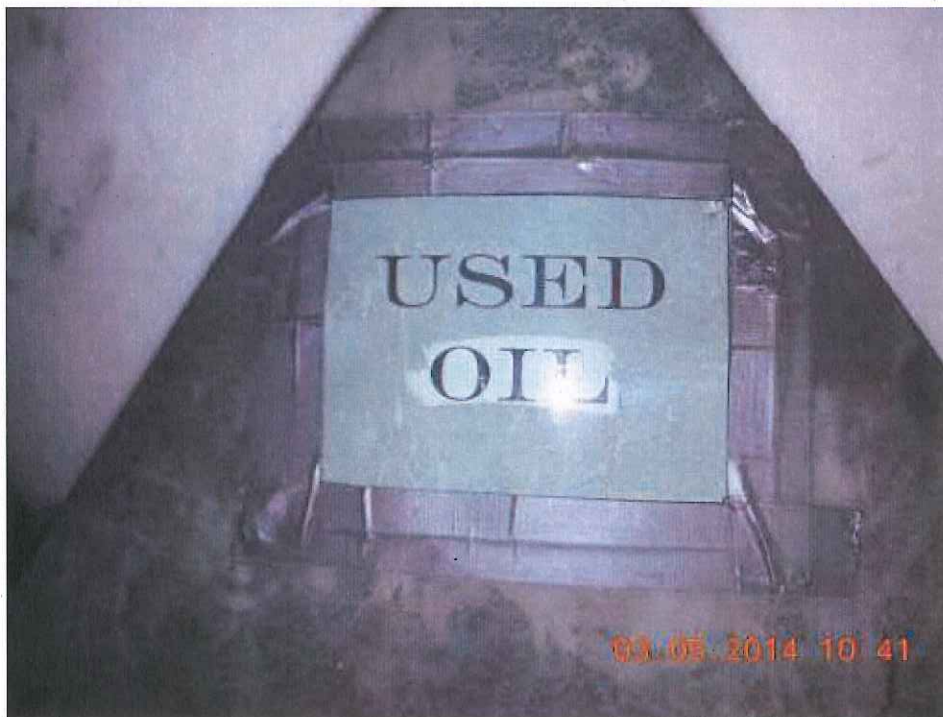
**Photo Number** 10

Label on the used oil bulk collection tank  
featured in photograph #9.
